## VACUUM LIFE ASSESSMENT OF A SAMPLE OF LONG SERVICE VACUUM INTERRUPTERS

### ABSTRACT

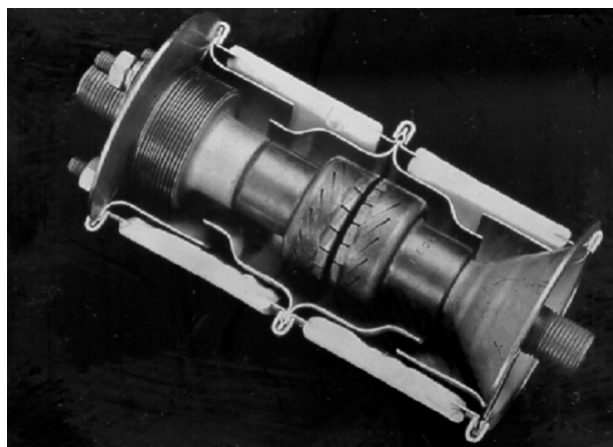
A typical VI is shown in Figure 1. It consists of two electrical contacts at the ends of thick copper conductors, which can be moved apart by the switchgear mechanism. The contacts are sealed into a vacuum container. One of the conductors has a metal bellows attached that allows the necessary movement of the contact.

**Figure 1: A Sectioned Vacuum Interrupter**

Due to the extremely high dielectric strength of a vacuum, it is normally necessary to open the contacts only 6-8mm for 12 kV systems and 12mm for 36kV systems.

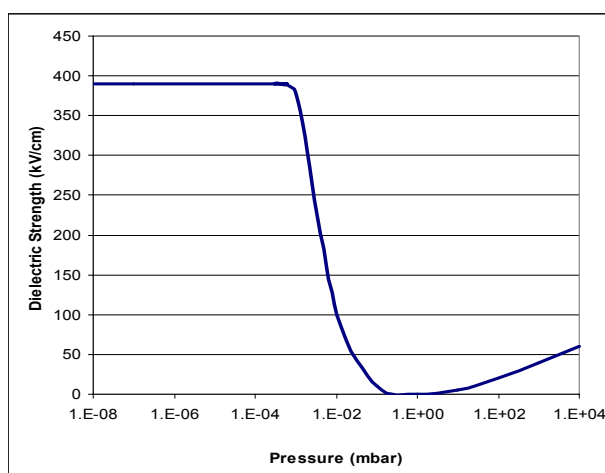
We need to consider how good a vacuum is required for operation of the VI in service. Fig. 2 shows the “Paschen curve” for dry air. We are interested in the left hand side of the curve, which shows a sudden increase in dielectric strength around  $10^{-2}$  mbar and then a constant dielectric strength for pressures below  $10^{-3}$  mbar. Any pressure lower than about  $10^{-3}$  mbar makes no difference to interrupter performance.

**Figure 2: The Paschen Curve, Showing How Breakdown Voltage Varies With Vacuum Pressure.** Note that pressure increases to the right, but degree of vacuum increases to the left.

If the pressure within the VI rises over time from the normal manufactured value (usually  $10^{-6}$  mbar) there is no effect until the “limiting value” of  $10^{-3}$  mbar is reached, after

which the insulation effect declines very rapidly with rising pressure. In vacuum interrupter design it is assumed that once an interrupter enters this declining zone it has failed, as it will quickly reach a point where the Transient Recovery Voltage cannot be withstood and the interrupter would then be incapable of interrupting even small currents.

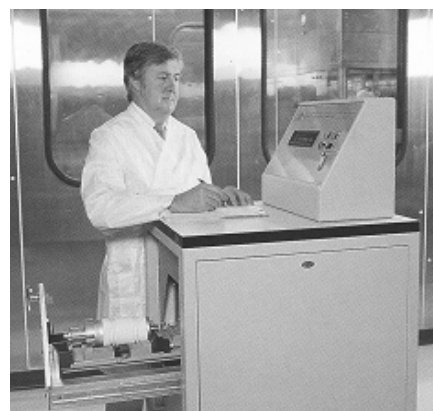
During manufacture, following seal-off interrupters are pressure tested using a magnetron pressure tester, Figure 3. An interrupter is placed inside a magnetic field coil, and voltage applied across it. A single small pulse of current passes, whose size is a measure of how much gas is inside the interrupter. Usually a second test is carried out a few days later, and any increase in the pulse size is an indication of leakage. Some leakage can be tolerated if it can be calculated that the pressure will still be within the safe limit in say 20 years time. Such testing equipment is believed to be used now by all manufacturers, but it is factory equipment and not available to users, or for use in the field. During the calculated vacuum life of the devices (in the industry this is termed the "Storage Life") the manufacturers claim, correctly, that the rigorous manufacturing quality control employed together with careful design mean that loss of vacuum is extremely unlikely and that a simple voltage test is sufficient to prove that the vacuum is intact. However although true for the 20 year Storage Life, this cannot hold true indefinitely. Put simply, if you keep any piece of equipment in service indefinitely it will eventually fail. What is critically needed now is some idea of when we can expect old VI beyond the design life to start failing. After reaching the critical value it is likely that a closed vacuum interrupter would continue to appear good for some time without any apparent problem, because its normal condition is contacts-closed. However if the switchgear then had to operate, and tried to commutate a short circuit current the failure could be catastrophic. To minimize this possibility the key question is "how can the condition of the vacuum insulation be verified?" Another

**Figure 3: A Magnetron Pressure Measuring Machine in a Factory**

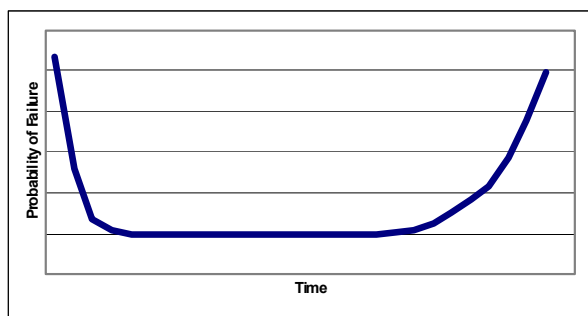
Historically VI have proven to be extremely reliable, but it would be unwise to extrapolate this experience to give an indefinite life. Most devices follow the Bathtub Curve of failure shown in Figure 4. There is a high failure rate for the early part of a product's lifetime, as manufacturing faults shake out, followed by a long period of stable low failure rates, which eventually is followed by a third stage of rising failure rates as age-related effects come into play. This is very familiar to the owners of motor cars. The excellent service experience of VI to date has been mainly within the

**Figure 4: The Bathtub Curve**

design life of the VI where the failure rates are expected to be very low. As the devices age they must eventually reach the third part of the bathtub curve and start to fail with increasing probability. Given long enough this will actually reach 100% failure probability. All machines die. The important question is, “how close are we to this third stage of failure?” If we knew this we could continue to use old VI for a period beyond their design life with very low risk.

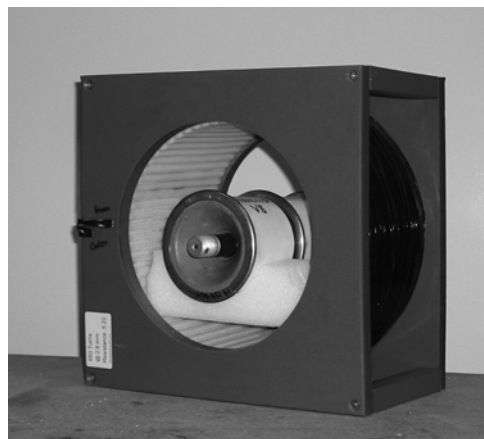
measuring apparatus for testing interrupters, similar to the ones used during manufacture [5]. Magnetic field is supplied by a solenoid using 40 kg of copper wire on a former 180mm long and with a central hole of diameter 250mm. Fig. 5. The coil is of optimised geometry and is powered by a 2kW dc current supply, giving a field of 700 Gauss.

**Fig. 5. A vacuum interrupter in the solenoid coil.**

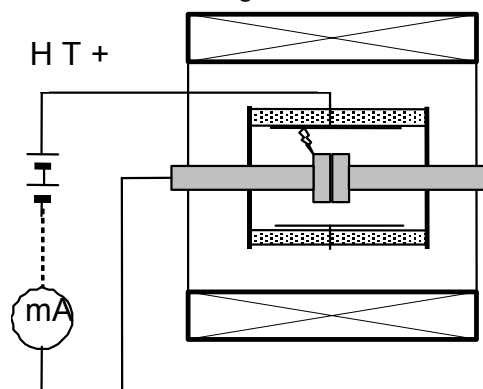
The high voltage supply provides up to 10kV, and has a current capacity of 10mA. Normally we test at 5kV. Figure 6 shows the circuit.

**Fig. 6. A schematic Magnetron Circuit.**

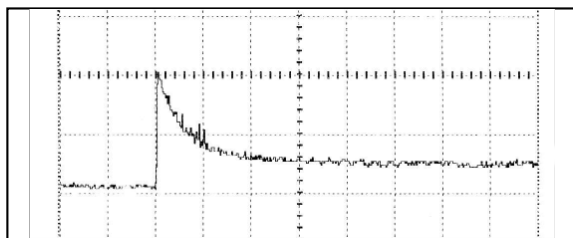
The pressure measured is proportional to the height of the current pulse, which may vary from about 2mV to 5000 mV. The captured pulse is displayed on a storage oscilloscope, Fig. 7. Since we can expect one day to have a failed interrupter under test, it has to be assumed that the full 10kV could be input to the data capture electronics, and precautions are taken to mitigate the effects of this.

**Figure 7. Typical magnetron pulse from an interrupter.**
